SF6 gas leak repair with Belzona

ID: 8533

Customer Location: Wind farm, Australia
Application Date: May 2021

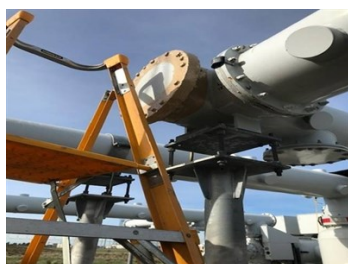
SF6 gas leaks were observed on flanges and needed to be sealed to prevent further leakage of this extremely potent greenhouse gas.

- * Picture 1: Wind farm ,
- * Picture 2: Leaking flange ,
- * Picture 3: Application of Belzona 1161 & 5831 ,
- * 4: Completed flange gas leak repair ,
