Belzona Prevents Slips & Trips by using a Positive Grip Coating System

ID: 8534

Industry: *Commercial Facilities*
Application: *FPA-Floor Problem Areas*
Substrate: *Aluminium*
Products: ** Belzona 4411 (Granogrip). ,*

Customer Location: *Bern, Switzerland*
Application Date: *May 2019*

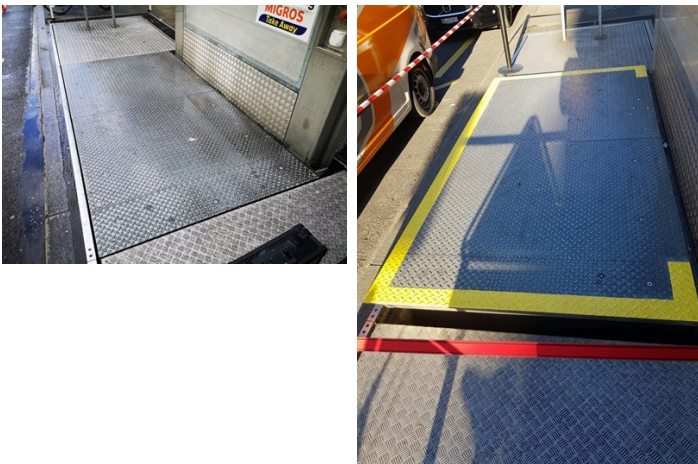
The customer wanted a coating that was both visible and tangible, as the loading ramp can be raised to 1.15m.

- * 1). Original condition without Belzona ,
- * 2). Security coating and marking area with Belzona 4411 ,

Aluminium checker plate loading ramp.

The surface was initially prepared using appropriate power tools. It was then coated using Belzona 4411, followed by the incorporation of Granogrip prior to being over coated with a second layer of Belzona 4411.

Belzona 4411 not only provided a visually striking coating that would raise visual awareness but thanks to the incorporation of aggregate fillers also provided a physically grippy surface making employees aware of the risk area they are operating within.
