Belzona 1331 rebuilds Turbine Cover in the Hydro Power Industry

ID: 8543

Customer Location: Austria
Application Date: March 2021

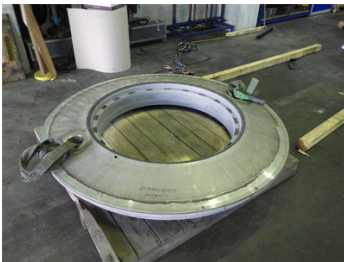
- * Image 1: Turbine Cover ,
- * Image 2: Identifying the issues 1: Worn ring (traces of erosion from the water) 2: Mating surfaces were coated in 3 layers 3: The undercut was coated in a single layer ,
- * Image 3: The lid after applying the first coat of Belzona 1331 ,
- * Image 4: Completed application after being machined. ,

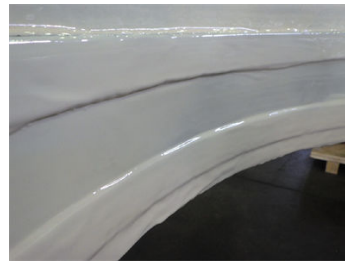
The turbine cover became oval due to welding work on the outer circumference. The fits on the inside diameter also warped. Since these surfaces already had their finished diameter, they should be built up with Belzona and then machined to the finished size.

Blasted to 110 μm roughness according to Testex with blasting agent Sintox 0.2-1.4 and corundum F14 (mixed 2: 1) Cleaned and degreased surfaces Build up the surfaces with the first layer of Belzona 1331 - target layer thickness 1000 μm Build up the mating surfaces with a second layer of Belzona 1331 after approx. 3 hours - target layer thickness 1000 μm Build up the mating surfaces with a third layer of Belzona 1331 after approx. 3 hours - target layer thickness 1000 μm in accordance with Belzona System Leaflet VPF_13
