Belzona Protects a Concrete Floor from Future Oil Ingress

Application: FPA-Floor Problem Areas

Customer Location: Switzerland, Vigier Perry

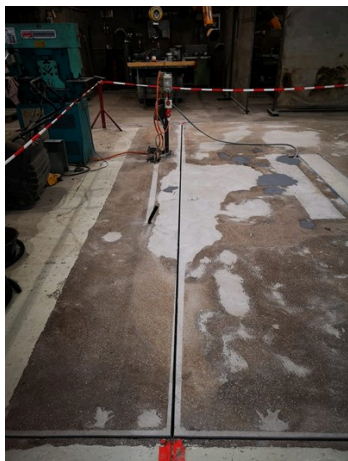
Removal and installation of the defective floor by scarifier/grinder.

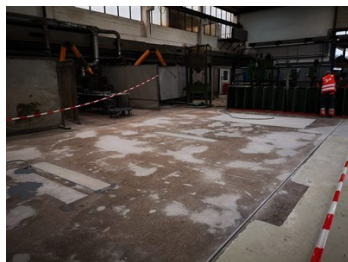
Cutting expansion joints and preparations for coating.

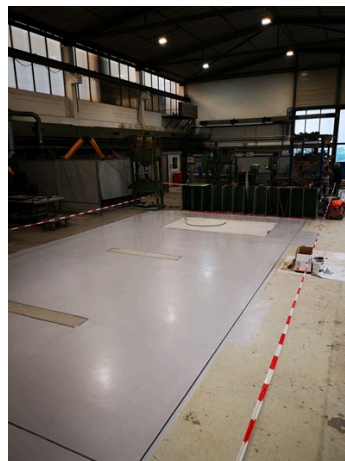
2x Coats of Belzona 5231 including recessing for new system parts.

The damaged floor was mechanically removed, cleaned and rebuilt, various areas sealed using Belzona 1111 and Belzona 1212. Followed by 2 coats of Belzona 5231. Finally, new expansion joints were formed using Belzona 4521. The application was carried out in accordance with Belzona System Leaflet FPA-01 & FPA-06
