# Belzona solution repairs Olympic Swimming Pool

ID: 8552

Corrosion beneath gaskets caused a damage to sealing faces

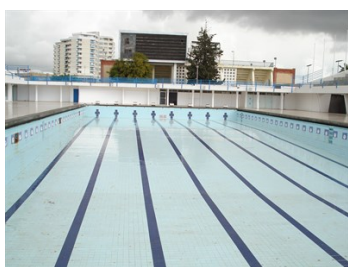
- \* 1 : Olympic Swimming Pool ,
- \* 2 : Under water window severely damaged ,
- \* 3 : Fixation ,
- \* 4 : Camera under water ,

Leakage of the under water window used for cameras

The application was carried out in accordance with Belzona Leaflets GSS-2. the area was prepared by rough grinding as well as the pre-formed seal, cleaned by Belzona 9111. Then the cold repair with Belzona 1111. Belzona conditioner 2911 was applied to both prepared surfaces. Application of Belzona 2211 and seal fixation.
