Belzona prevents wear on an ash slurry mixer

ID: 8555

Cogen powerplant ash slurry mixer

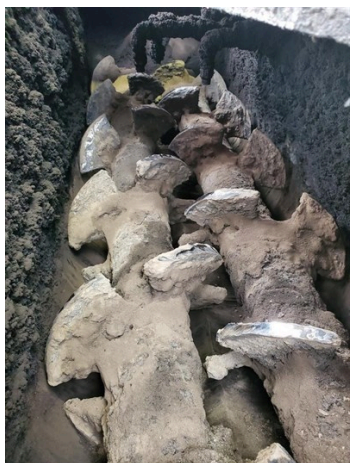
The paddles on their ash slurry mixer would wear down to less than half of their original length in 3 months forcing them to be replaced. The original paddles were made from hardox steel. The mixer box and shafts had some mild wear and corrosion as well.

- * 1. Original condition ,
- * 2. Box coated with Belzona 1331 ,
- * 3. Shafts coated with Belzona 1331 ,
- * 4. Paddles being coated with Belzona 1813 ,
