VOLUTE PUMP INTERNAL LINING REPAIRED WITH CHEMICAL RESISTANT PROTECTIVE COATING

ID: 8557

Customer Location: POWER PLANT RAS LAFFAN QATAR

Application: CEP-Centrifugal Pumps

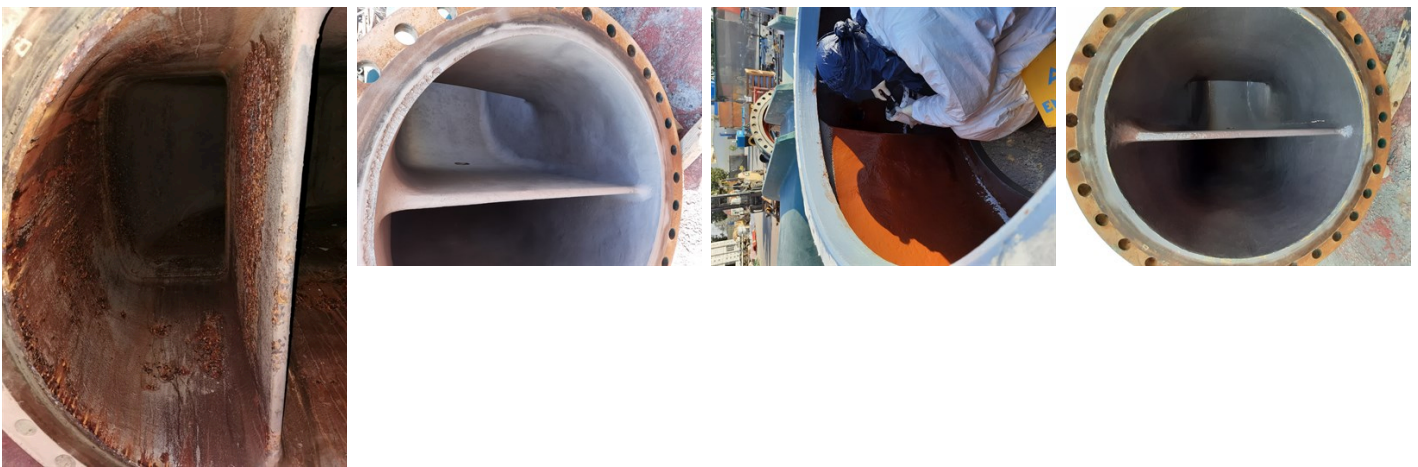
INTERNAL LINING WAS SEVERELY DAMAGED, GENERAL CORROSION ALL OVER THE SURFACE IS EVIDENT AND DEEP PITTING ON INLET SITTING AREA AND ON OUTLET FLANGE FACE

- * 1) APPEARANCE OF THE PUMP BEFORE BLASTING ,
- * 2) PUMP AFTER BLASTING ,
- * 3) DURING COATING APPLICATION ,
- * 4) APPLICATION COMPLETE WITH BELZONA 4311 ,

SURFACE PREPARATION BY GRIT BLASTING IS CARRIED OUT TO REMOVE RUSTS AND CORROSION RESIDUES AS WELL AS TO EXPOSE UNFORSEEN PITTING TO EVALUATE THE AMOUNT OF CAULKING MATERIAL TO BE USED. REBUILDING APPLICATION ON ALL EXPOSED PITTING TAKES PLACE AFTER BLASTING IS COMPLETED AND CURED FOR 2 HOURS. AFTER CURING, SWEEP BLASTING HAS BEEN CONDUCTED ALL OVER THE SURFACE WHICH INCLUDES THE SURFACE OF THE REBUILDING MATERIAL, FOLLOWED BY APPLICATION

OF BELZONA 4311 CHEMICAL RESISTANT COATING IN TWO COAT SYSTEM.
