Bush housing bonded in place with Belzona

ID: 8559

Application: *ENC-Engines and Casings*

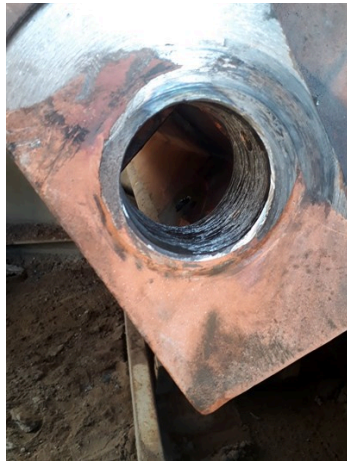
- * 1 - Conveyor system ,
- * 2 - Surface preparation on the housing ,
- * 3 - Bushing to be bonded in place ,
- * 4 - Belzona 1111 Supermetal applied & bushing bonded ,

A bush housing had become oversize due to wear & corrosion. The bush was spinning whilst the machinery was in operation, this was causing further wear.

The housing & bush were prepared using an angle grinder. Belzona 1111 (Supermetal) was then applied to both parts. The bush was then inserted & aligned.
