Repair of drinking water tank with Belzona 5811DW2

ID: 8560

Renovation of a Water tank on site using a Belzona Drinking Water approved coating.

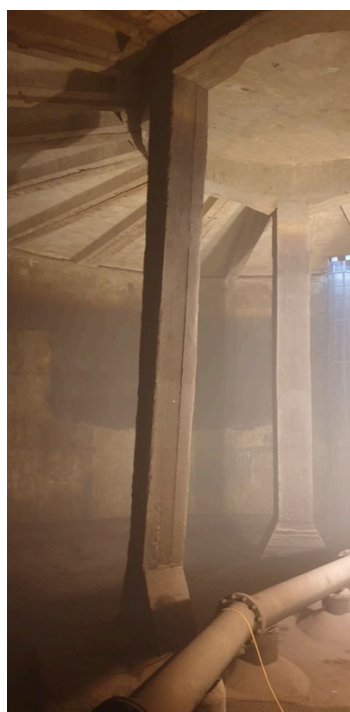
The concrete walls of the water tank had corroded over time leading to deterioration of the substrate subsequently leading to a poorer quality water quality.

- * Image 1: Inside of the Water Tank ,
- * Image 2: Re-Build of the Concrete using Belzona 4111 ,
- * Image 3: Spraying Belzona 5811DW2 ,
- * Image 4: Completed Application ,

The Belzona products were applied in accordance with the Belzona System Leaflet TCC_5.
