Belzona Strengthens Nozzles of TEG Flash Tanks on Offshore Platform

ID: 8568

Industry:	Oil & Gas	Customer Location:	China
Application:	VPF-Valves, Pipes and Fittings	Application Date:	2017
Substrate:	Carbon Steel		
Products:	* Belzona 1111 (Super- Metal) Belzona 1983 (Belzona Superwrap II Resin) Belzona 9381 Belzona 9382 Belzona 9111 (Degreaser) Belzona 9611 ,

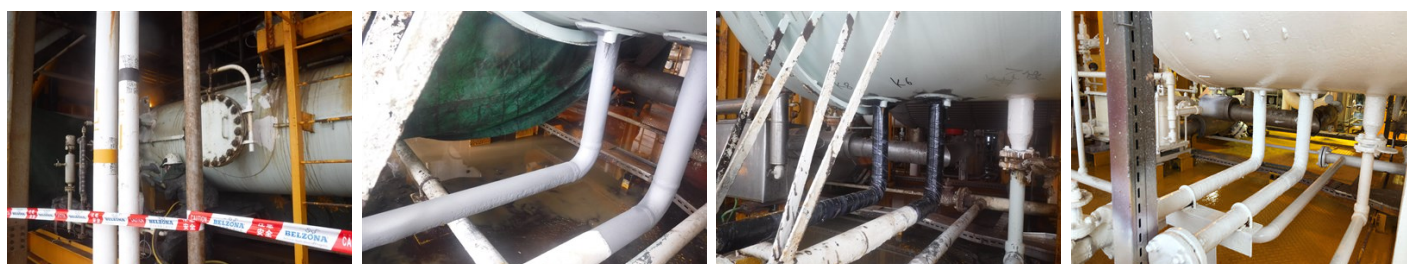
Photograph Descriptions

Due to the damage of the original insulation layer, nozzles of the TEG flash tank were corroded under the insulation layer (CUI). The nozzles had developed thin-wall defect and through-wall defect.

- * 1. Surface preparation ,
- * 2. Nozzles after blasting ,
- * 3. Complete application of Belzona Superwrap II ,
- * 4. View of nozzles after 3 years ,

The repairs were designed in accordance with ISO24817 standard. The application was completed by Belzona trained and validated installers in accordance with Belzona Know-How System Leaflet VPF-11. Belzona supervisor and the on-site representative supervised the whole process. The whole application involved 8 two-inch nozzles.

standard of ISO24817and ASME PCC-2, Belzona Superwrap II can repair the nozzles of pressure vessels on-site, with no downtime or hot work required. The application is still in good condition after 3 years.
