# Belzona Repairs Nozzles with Through-wall Defect Online on Offshore Platform

ID: 8571

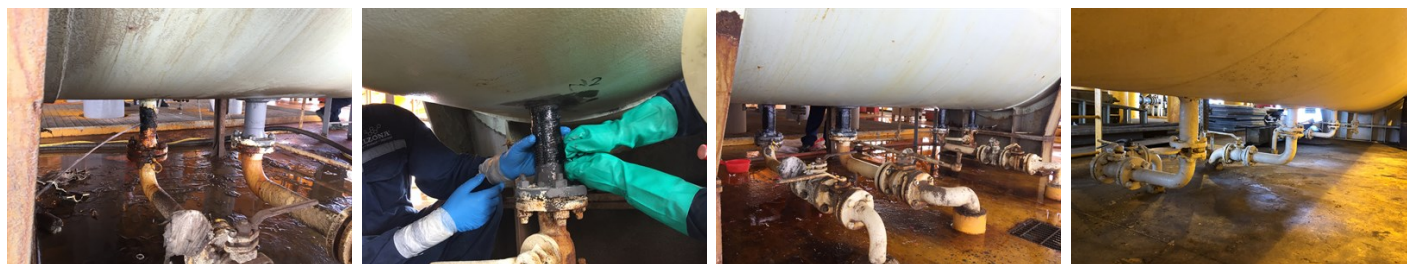
The nozzles of closed drain drum had developed thin-wall defect and through-wall defect due to CUI.

- \* 1. Nozzle with through-wall defect ,
- \* 2. During Belzona Superwrap II application ,
- \* 3. Complete application of Belzona Superwrap II application ,
- \* 4. View of nozzles after 3 years ,

Nozzles of closed drain drum on offshore platform suffering from corrosion and significant thickness loss. The design pressure is 0.35MPa, the design temperature is -3°C~110°C.

The repairs were designed in accordance with ISO24817 standard. The application was completed by Belzona trained and validated installers in accordance with Belzona Know-How System Leaflet VPF-11. Belzona supervisor and the on-site representative of BV supervised the whole process. The whole application involved 2 one and half-inch nozzles, 15 two-inch nozzles, 1 three-inch nozzle and 4 four-inch nozzles. One of the 2" nozzles has developed through-wall defect.

For conventional welding, the whole closed drain drum need to be shut down and isolated, with thorough cleaning and water injection, which costs at least 15 days of downtime and affects the production. Welding in confined space may also cause hazards. Therefore, the customer has been looking for the solutions with no hot work required but also accepted by classification society. Meeting the standard of ISO24817 and ASME PCC-2, Belzona Superwrap II can repair the nozzles of pressure vessels on-site, with no downtime or hot work required. The application is still in good condition after 3 years.
