# BELZONA SUPERWRAP II REPAIRS UNDERGROUND PIPELINE ADDING 15 YEARS SERVICE LIFE

Industry: Oil & Gas

Application: VPF-Valves, Pipes and Fittings

Customer Location: Victoria, Australia

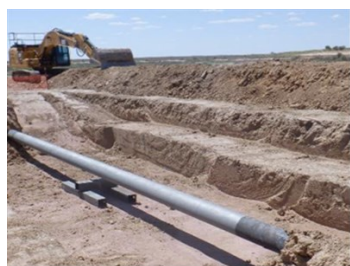
- \* 1. Pipe being excavated ,
- \* 2. Wetting out the substrate with Belzona 1982 resin ,
- \* 3. Release film over the wrap waiting to cure ,
- \* 4. Completed 8.1 m long application ,
