BELZONA RE-SURFACES WATER PARK FLOORS

Industry:	General Industry	Customer Location:	Water Park - Oklahoma
Application:	FPA-Floor Problem Areas	Application Date:	May 2007
Substrate:	Concrete		
Products:	Belzona® 5111 (Ceramic Cladding) Belzona® 9221 (Surefoot Aggregate White)

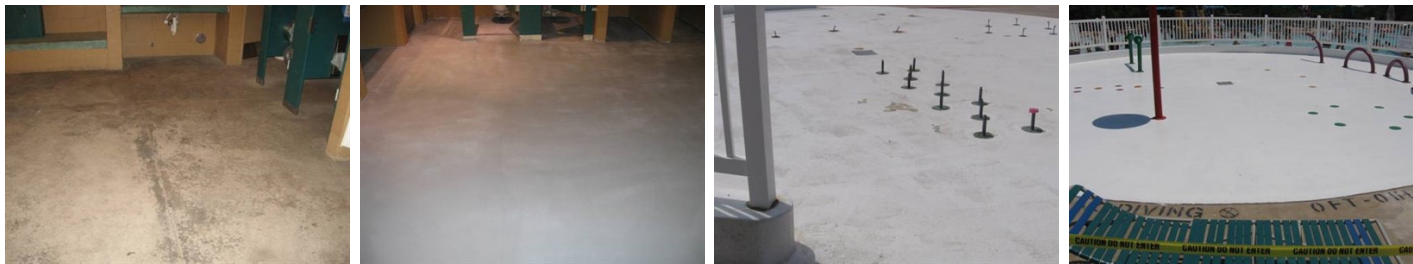
Photograph Descriptions

Painted floors in bathrooms and outside surfaces were wearing out on a yearly basis and the city was looking for a long term solution.

- * Bathroom floors before application. ,
- * Bathroom floors after Belzona® 5111 was applied. ,
- * Outside surfaces before application. ,
- * Outside surfaces after Belzona® 5111 application. ,

The application was carried out in accordance with Belzona System Leaflet FPA-8.

Belzona product was found to provide a long term solution compared to original paint system which required annual replacement.
