Belzona 7211 Deep Pour Grout for Tank Base

ID: 8581

Industry: Chemical & Petrochemical
Application: TCC-Tanks and Chemical Containment Areas
Substrate: Steel
Products: * Belzona 7211 ,
* Belzona 5811 (Immersion Grade) ,
* Belzona 5111 (Ceramic Cladding) ,

Customer Location: Montana USA
Application Date: August 2020

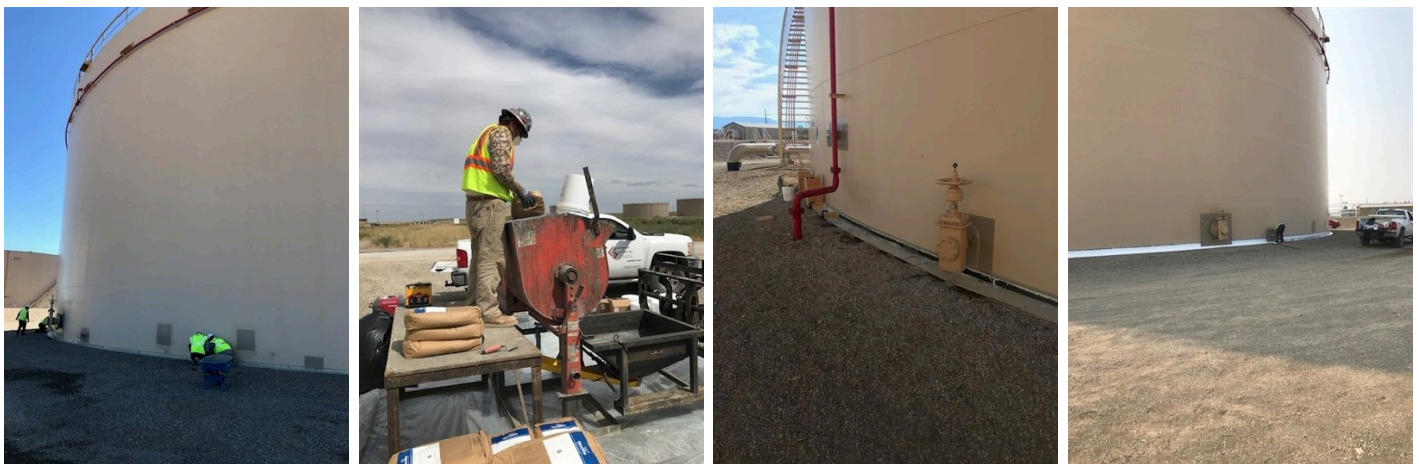
Photograph Descriptions

The wall of this petroleum storage tank had heavy loads on it, but the base of the tank wall was not resting on the annular ring.

- * 1) Sections of failing Cementous grout easily removed in sections. ,
- * 2) Belzona 7211 mixed and transported to pour site where form work and head boxes were installed. Belzona 5811 was used in sections less than 2" deep. ,
- * 3) View of a section being poured next to previously poured section. Work was done in sections to prevent excessive loads without a base. ,
- * 4) Belzona 5111 being applied to provide an UV resistant coating over grout. ,

Application required filling the existing gap between the tank annular ring and base.

A head box was used to apply the material with simple form work.

The ability to grout the tank with proper materials put this tank back in service as it could not be used in this condition. This increased the storage capacity at this terminal considerably and restored this asset. Belzona 7211 and 5811 will not shrink and have high compressive loads preventing future failure and water ingress that causes freeze thaw problems.
