Belzona Re-seats Bearing on Rudder Shaft

ID: 8590

Industry:
Application: *SOS-Ships and Offshore Structures*

Customer Location: *Nova Scotia, Canada*
Application Date: *September 2021*

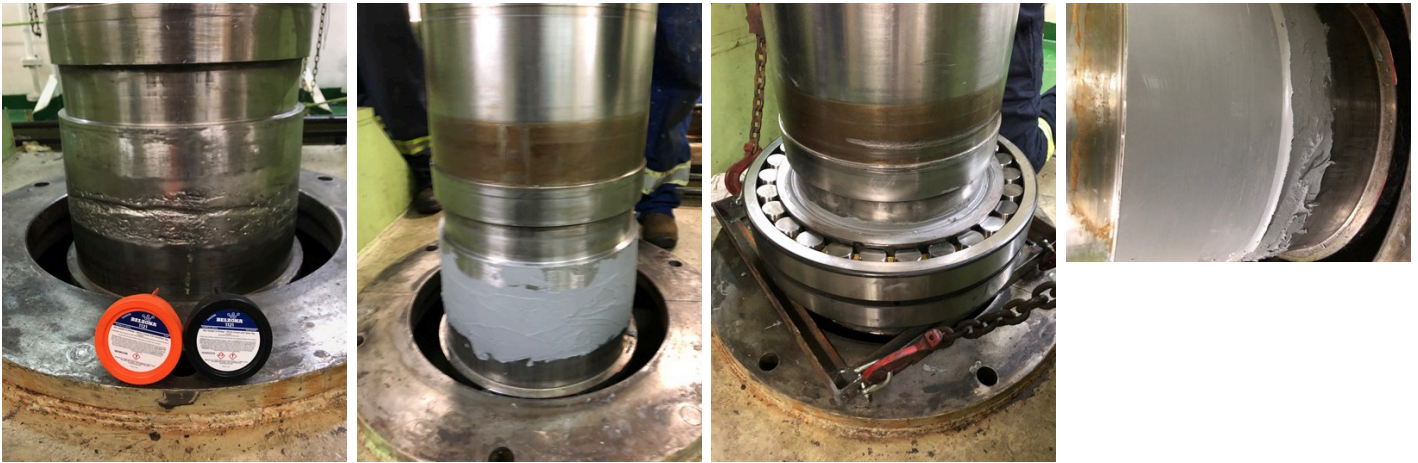
Photograph Descriptions

Rudder shaft was worn under the bearing requiring repairs to the shaft for full bearing contact.

- * 1. Damaged shaft after preparation. ,
- * 2. Belzona 1121 applied onto the shaft and bearing. ,
- * 3. Bearing lowered into position for curing. ,
- * 4. Bearing removed and Belzona 1121 inspected. ,

The new bearing was used as a former using the slip method following a modified version of Belzona Know How repair leaflet SOS-9. Two coats of Belzona 9411 release agent were applied on the inside of the new shaft bearing and allowed to fully dry. Shaft was prepared using power tools to remove all corrosion deposits and loose substrate. Belzona 1121 Super XL-Metal was mixed and applied by brush onto the shaft and the inside of the bearing. Additional Belzona 1121 was troweled onto the shaft and bearing. Bearing was lowered onto the shaft, excess Belzona 1121 was removed, and the repair was allowed to cure for 24 hours. The bearing was removed to inspect that there was at least 80% contact between the shaft and bearing.
