Belzona Provides Abrasion Resistance to Chutes in Recycling Plant

Customer Location: Aluminium Ingot Plant, UK

Application Date: August 2021

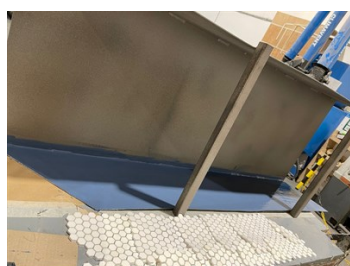
* 1. Newly fabricated chutes grit blasted and lined with Belzona 1321 2. Belzona 9811 Alumina tiles adhered to the Belzona 1321 3. Belzona 9811 Alumina tiles bonded in place using Belzona 1321 4. Newly fabricated abrasion-resistant chutes ready for delivery to the customer ,

New steel chutes were fabricated and delivered to Belzona Wrexham workshop. The chutes were then grit blasted, cleaned and degreased in preparation for the Belzona application. A single coat of Belzona 1321 (Ceramic S-Metal) was then applied. A sheet of Belzona 9811 (Alumina Tiles) was then tenaciously bonded into the Belzona 1321 which is used as an adhesive. Once cured, Belzona
