Belzona Overhauls a Pump in a Waste Incineration Plant

Customer Location: Poland
Application Date: October 2021

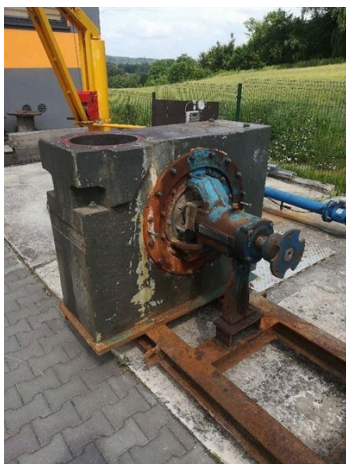
- * 1 - Damaged Pump ,
- * 2 - Cracked Casing to be repaired with Belzona 1111 ,
- * 3 - Internal Lining coated Belzona 1381 ,
- * 4 - Completed Application ,

Duchting Pumpen MC 300-500 after many years of operation was damaged by numerous body cracks and other damage.
