# Belzona Overhauls a Pump in a Waste Incineration Plant

ID: 8620

Customer Location: Poland  
Application Date: October 2021

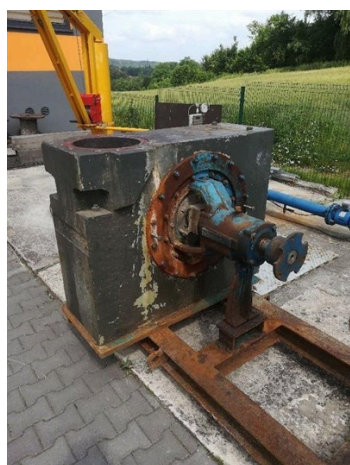
- \* 1 - Damaged Pump ,
- \* 2 - Cracked Casing to be repaired with Belzona 1111 ,
- \* 3 - Internal Lining coated Belzona 1381 ,
- \* 4 - Completed Application ,

Duchting Pumpen MC 300-500 after many years of operation was damaged by numerous body cracks and other damage.
