# Belzona prevents water damage on a hospital roof

ID: 8629

Industry: *Buildings & Structures*  
Application: *RPA-Roof Problem Areas*  
Substrate: *Metallic Joints*  
Products: *\* Belzona 3121 (MR7) ,*

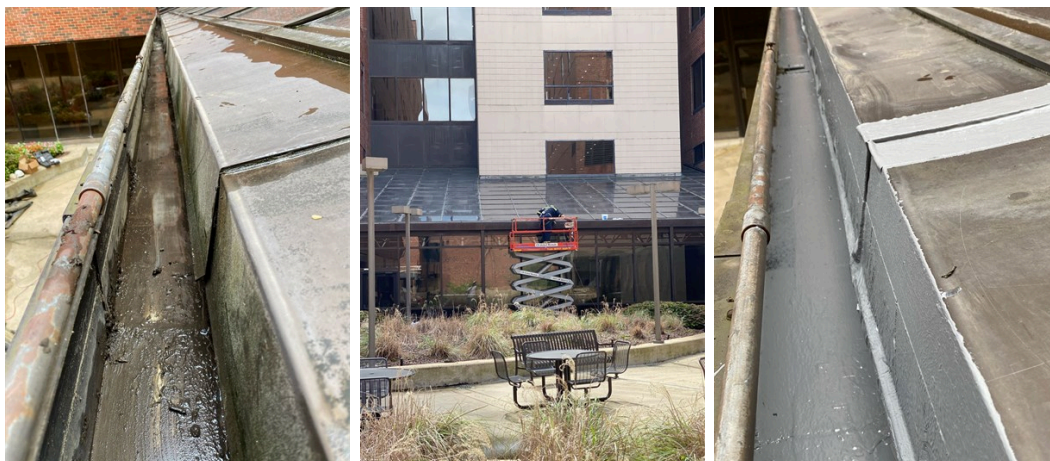
*Rainwater was penetrating into the building*

- \* 1. Original condition of the guttering ,
- \* 2. Application in progress ,
- \* 3. Completed application ,

Rainwater was filling the gutters and entering behind the flashing into the building.

The application was cleaned of any loose material and degreased. The first layer of Belzona 3121 (MR7) was applied and the reinforcement sheet stipled in. Then the 2nd coat was applied and left to cure.
