Belzona Protects Sewage Treatment Plant

Application: TCC-Tanks and Chemical Containment Areas

Substrate: Concrete

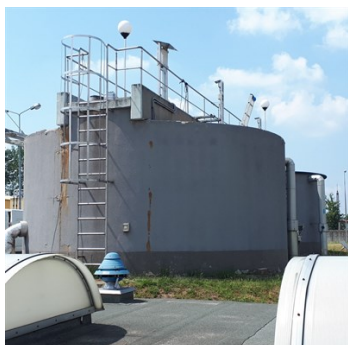
Strong and progressive corrosion of the concrete in the area of the sewage mirror and in the ceiling part of the sludge thickener.

- * 1. Treatment tank ,
- * 2. Area to be repaired ,
- * 3. Area rebuilt ,
- * 4. Area protected with Belzona 5811 ,

The concrete defect areas were rebuilt and then protected using Belzona 5811

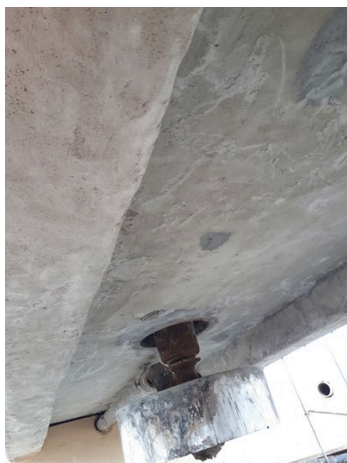
Deterioration on the surface of the raw sludge thickener in the sewage treatment plant, meant that repair and protection was required
