Belzona Flexible Membrane Protects Concrete Tower Foundation

Customer Location: Nova Scotia, Canada

Application: WPA-Wall Problem Areas

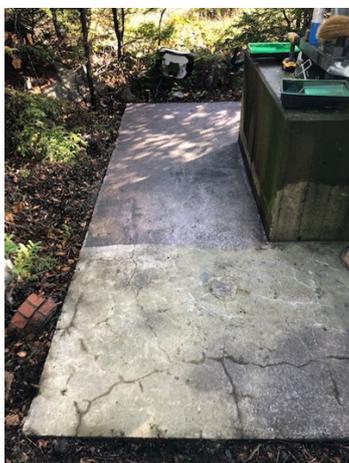
- * 1. Cleaned foundation. ,
- * 2. Foundation conditioned with Belzona 3911. ,
- * 3. Finished Belzona 3111 application. ,
- * 4. Membrane in good shape one year following application. ,

The coating application followed Belzona procedure WPA-1 for protecting and weatherproofing external surfaces. The foundation was first cleaned to remove all dirt and debris then conditioned with Belzona 3911. Once the Belzona 3911 dried, the Belzona 9311 reinforcement sheet was incorporated into the first coat of Belzona 3111. Once the first coat was adequately dry, the second coat of

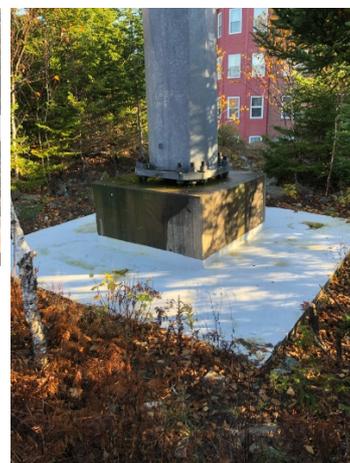
Epoxy coatings have not performed well with the utility for the purpose of preventing water from getting into foundation cracks. The Belzona 3111 membrane was used as a trial for the benefit that the membrane will keep water out, and is flexible which means no cracking like an epoxy coating. The second coat of Belzona 3111 membrane was applied several hours before a Fall rain storm. The Belzona 3111 Membrane was unaffected by the rain, and continued to cure once the weather dried up. One year after the application and the membrane is still in good shape with water ponding on the top.
