SUMP REPAIR WITH BELZONA AT YEAST PLANT

ID: 866

Customer Location: *Yeast Producer, Memphis, TN*
Application Date: *March 2007*

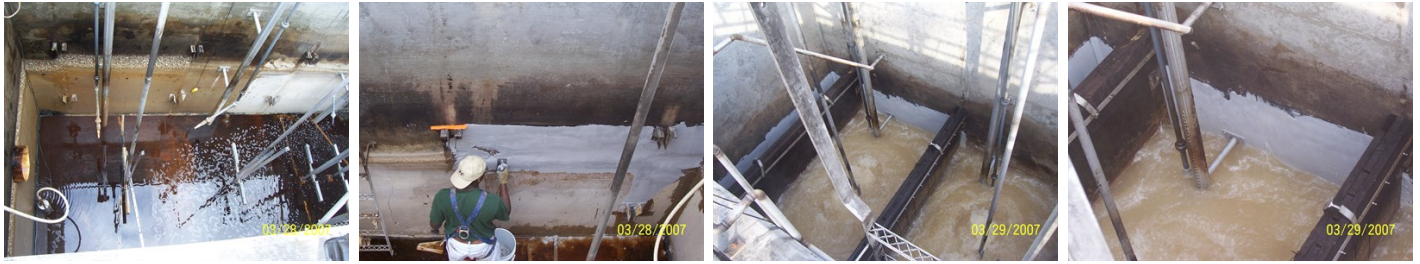
Photograph Descriptions

After years of running 24 hours a day, 7 days a week the sump had erosion and corrosion from chemical attack at the water level.

* Sump prior to repair , * Sump under repair , * Sump after repair , * Sump after repair ,

This application was carried out in accordance with Belzona Know-How System Leaflet FPA-10.

The Belzona® 4111 will hold up to the the chemical attack providing long life to the sump. The Belzona solution provided the customer the ability to be back on-line in under 24 hours.
