BELZONA REPAIRS BIODIESEL COLUMN

ID: 867

Customer Location: Biodiesel Producer, Memphis, TN
Application Date: November 2006

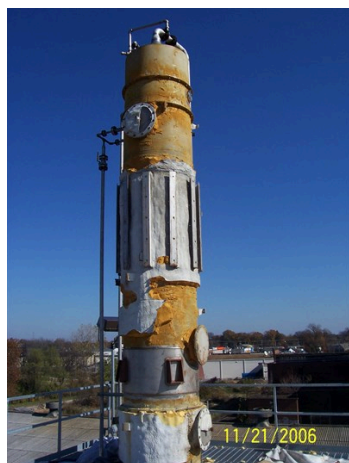
Due to stress on a flange there was a crack at the weld causing Biodiesel to leak. This was 130 feet above the ground.

* The column to be repaired , * Column under repair , * Repaired area on column , * Repaired area close-up ,

Application was carried out in accordance with Belzona Know-How System Leaflet CEP-3 & 6.

The Belzona solution offered the customer quick turn-around, without the expense of having to empty the column which they would have had to do if welding.
