# BELZONA REPAIRS BIODIESEL COLUMN

Industry: Chemical & Petrochemical  
Application: CEP-Centrifugal Pumps  
Substrate: Stainless Steel  
Products: Belzona® 4301 (Magma CR1 Hi-Build)

Customer Location: Biodiesel Producer, Memphis, TN  
Application Date: November 2006

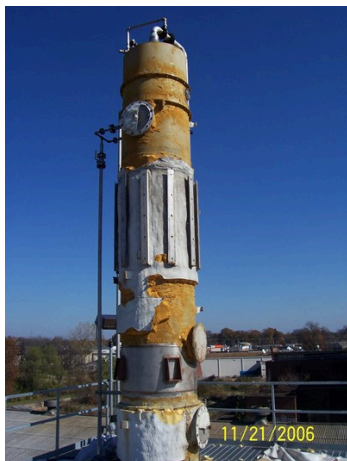
Due to stress on a flange there was a crack at the weld causing Biodiesel to leak. This was 130 feet above the ground.

\* The column to be repaired , \* Column under repair , \* Repaired area on column , \* Repaired area close-up ,

The Belzona solution offered the customer quick turn-around, without the expense of having to empty the column which they would have had to do if welding.
