Marine Sewage tank repaired with Belzona

ID: 8676

Customer Location: Scotland
Application Date: December 2021

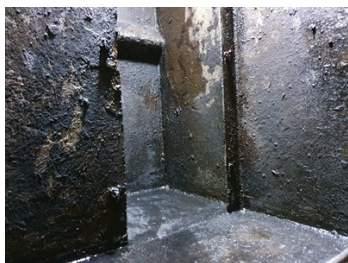
- * 1 - Existing coating system breaking down ,
- * 2 - Belzona Superwrap II system applied to the base of the tank ,
- * 3 - 1st coat of Belzona 5811 applied ,
- * 4 - 2nd coat of Belzona 5811 applied & left to cure ,

A marine sewage tank was identified as having thin wall areas on its base caused by corrosion. The existing protective coating system inside the tank had broken down. A repair & protection system was required to extend the life of the asset.
