# Marine Sewage tank repaired with Belzona

ID: 8676

Application: VPF-Valves, Pipes and Fittings

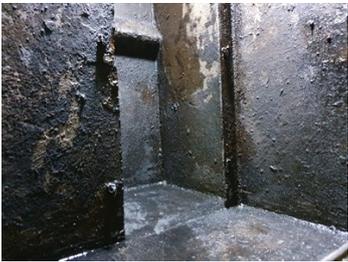
- \* 1 - Existing coating system breaking down ,
- \* 2 - Belzona Superwrap II system applied to the base of the tank ,
- \* 3 - 1st coat of Belzona 5811 applied ,
- \* 4 - 2nd coat of Belzona 5811 applied & left to cure ,

A marine sewage tank was identified as having thin wall areas on its base caused by corrosion. The existing protective coating system inside the tank had broken down. A repair & protection system was required to extend the life of the asset.

The application was carried out in a modified version of Belzona System Leaflet VPF-11 The tank internals were grit blasted to SA2.5 & 75 microns. All of the existing lining was removed. Areas of pitting and metal loss were faired with Belzona 1212. The full tank floor was then reinforced with the Belzona Superwrap II system. Two coats of Belzona 5811 were then applied over all areas of the
