Belzona Repairs Multi-Stage Pump

ID: 8683

Industry: Power
Application: CEP-Centrifugal Pumps
Substrate: Steel
Products: * Belzona 1111 (Super Metal) ,
* Belzona 1341 (Supermetalgilde) ,

Customer Location: South Africa
Application Date: 2021

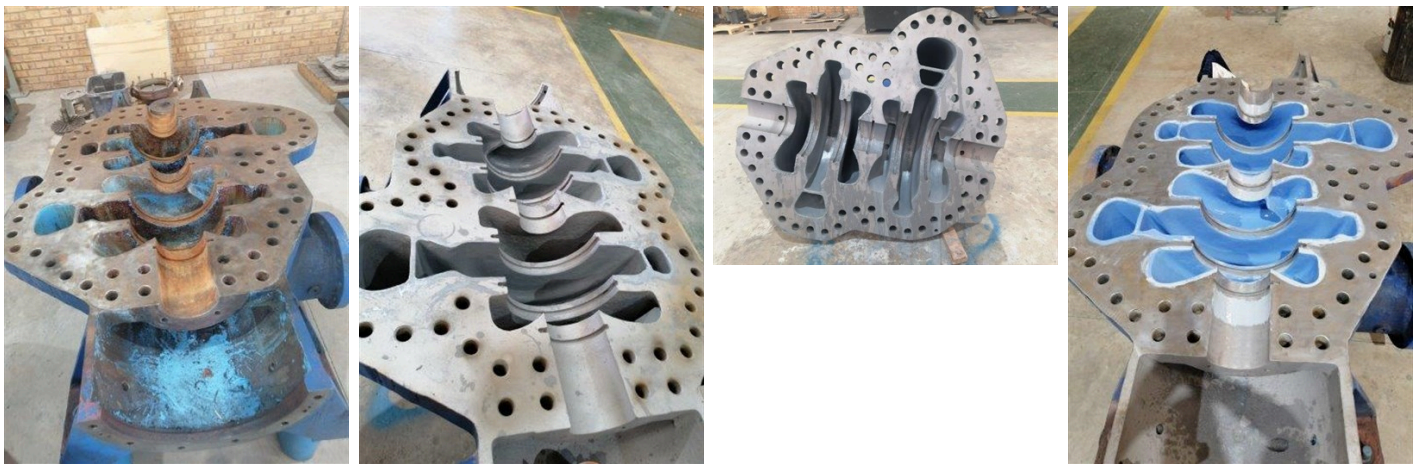
Photograph Descriptions

The process fluid had, over time, worn away the existing lining and damaged the substrate.

- * 1. Before Repair ,
- * 2. After Blasting ,
- * 3. Rebuilt ,
- * 4. Finished application ,

A multi-stage pump operating in a power station was badly worn, resulting in efficiency losses. A solution was required to rebuild the substrate and increase its efficiency.

The substrate was prepared using grit blasting to a SA2.5 cleanliness standard and an average surface profile in excess of 75 microns. Belzona 1111 (Super Metal) was then applied to restore the substrate followed by the application of Belzona 1341 (Supermetalgilde) to provide long term protection. System leaflet CEP-03
