# Belzona restores and protects a Hydro Unit

Customer Location: NW Washington  
Application Date: April 2021

60 year old Kaplan hydro power unit.

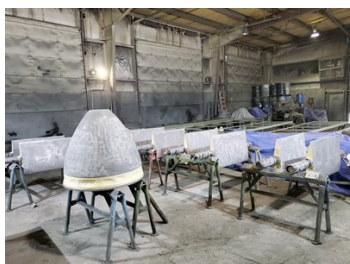
- \* 1. Belzona 1111 applied. ,
- \* 2. Belzona 1341 applied. ,
- \* 3. Assembled, and final touch-ups complete. ,
- \* 4. Unit reinstalled. ,

The parts were all grit blasted and washed with solvent. Belzona 1111 was used to smooth over the wear and cavitation in a full skim coat. Once cured, the Belzona 1111 was sanded down to the required profile, and frost blasted. Two full coats of Belzona 1341 were then applied. As per Belzona system leaflet VPF-01, VPF-02.
