# Belzona 3121 Relines Valley Gutter at Large Hospital

ID: 8689

**Industry:** Buildings & Structures  
**Application:** RPA-Roof Problem Areas  
**Substrate:** Steel valley gutter with previous failed coatings  
**Products:** \* Belzona 3121 (MR7) ,  
\* Belzona 9331 ,

**Customer Location:** Nottingham, UK  
**Application Date:** December 2021

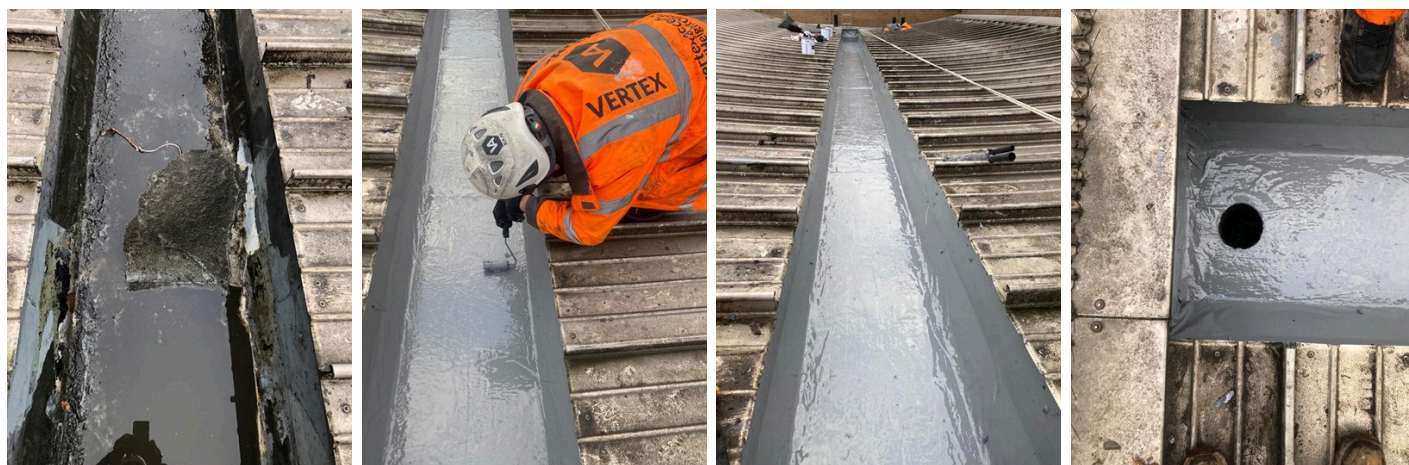
*The leaks were worsening and the client tried a number of solutions and a number of contractors, all without a good result. Belzona was approached by a contractor and Belzona 3131 was specified, but was later changed to Belzona 3121 (MR7).*

- \* 1. Before Application ,
- \* 2. During Application ,
- \* 3. After Application ,
- \* 4. Completed Gutter and Downpipe ,

A single valley gutter has repeatedly leaked over a crucial part of the hospital. It was metal/plastisol construction with sealed joints every 3 metres. The total area surface area was 12 square meters.

All surfaces were prepared in line with the Belzona 3121 Instructions For Use. The first coat was applied to the prepared substrate along with Belzona 9331 reinforcing sheet, ensuring the fibrous side of the sheet was facing down. The product was overlapped on either side of the central run by approximately 0.5" (12.5mm). This was applied in accordance with Belzona System Leaflet RPA-06.
