# Belzona Saves Cast Aluminium Mandrel

ID: 8699

Industry: Mining & Quarrying  
Application: MPT-Mechanical Power Transmission

Substrate: Aluminium  
Products: \* Belzona 1511 (Super HT-Metal),

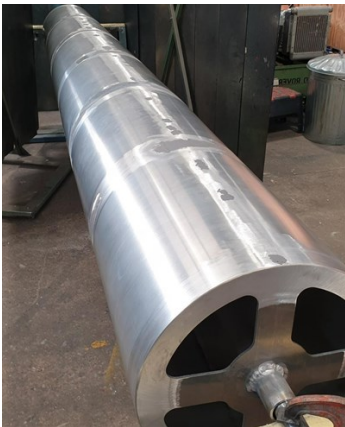
- \* 1. Belzona 1511 applied ,
- \* 2. Belzona 1511 applied (close-up) ,
- \* 3. Mandrel repair complete with Belzona 1511 smoothed ,
- \* 4. Close up of completed works ,

The product was applied in accordance with Belzona System Leaflet MPT-1. After surface preparation, the Belzona 1511 was applied to the surface and smoothed down until it sat flush with the aluminium substrate.
