SIMPLE OVERHEAD REPAIRS WITH BELZONA® 4141

Application: RPA-Roof Problem Areas

Customer Location: Electricity Distribution Company

Concrete support columns for electricity supply cables at local sub-station

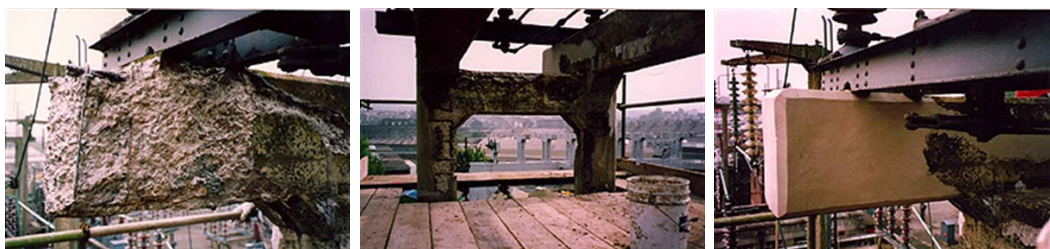
Severe spalling of the concrete accelerated by the acidic atmosphere generated by local industries

- * Close up of the badly spalled concrete ,
- * Work carried out from simple scaffold platform ,
- * Close-up of a rebuilt beam prior to application of Belzona® 5151 ,

Application was carried out using similar techniques to those detailed in Belzona Know-How leaflet RPA-2. Repairs were finally overcoated with Belzona® 5151 as preventive maintenance on surrounding concrete surfaces.

Use of Belzona® 4141 allowed rebuilding to be carried out without the need to construct special shuttering and use of Belzona® 5151 will ensure similar problems on surrounding areas will not occur.
