Stay Ring and Draft Tube Repaired with Belzona

Customer Location: Hydroelectric Power Plant, Turkey
Application Date: October 2021

Repair of a stay ring and draft tube in a 20Mw hydroelectric power plant, consisting of 3 units.

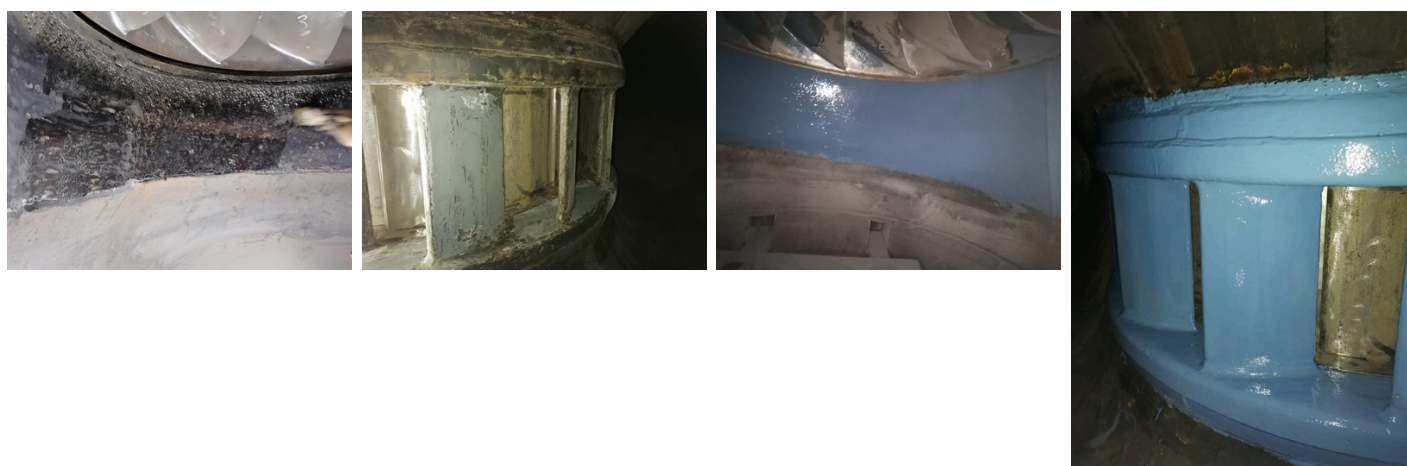
Photograph Descriptions

Foreign matter such as sand & stones entrained within the water had caused the stay ring and draft tube to erode and loose thickness over time. The equipment had also been subjected to general erosion-corrosion due to the nature of fluid handling equipment.

- * 1.) The damaged stay ring prior to application ,
- * 2.) The stay vanes prior to application ,
- * 3.) The stay ring after application ,
- * 4.) The appearance of the fixed wings after coating with Belzona 1341 ,

After mechanical cleaning of the substate, the surface was cleaned with Belzona 9111. After cleaning, any loss of substrate was rebuilt with Belzona 1311. Finally, Belzona 1321 was applied to the draft tube area and Belzona 1341 was applied to the stay ring and vanes for efficiency enhancement.
