# Restoration of Turbine Stay Ring and Vanes with Belzona

**Customer Location:** Hydroelectric Power Plant, Turkey  
**Application Date:** November 2021

Repair of the stay rings and draft tube of a 140Mw turbine operating within a hydroelectric power plant.

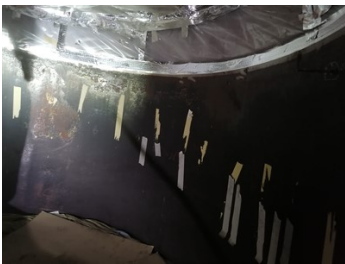
After 10 years of operation, the stay ring and vanes had lost thickness due to erosion. During a routine inspection, the surfaces had also been identified as being rough, resulting in a loss of efficiency and an increase in power consumption. The cause of roughness on the stay ring and vanes was because of foreign matter (sand, silt, mud etc.) within the process.

- \* 1.) Damaged stay ring prior to application ,
- \* 2.) The fixed wings before the application ,
- \* 3.) The stay ring after the application ,
- \* 4.) Final application - Belzona 1341 + Belzona 2141 ,

First, the turbine was grit blasted to SA2.5, achieving a surface profile of 75 microns before being cleaned with Belzona 9111. Once the surface was clean & dry, the pitted stay ring, vanes and draft tube were rebuilt with Belzona 1311, restoring the equipment back to its original dimensions. After the Belzona 1311 had cured, the surface was frost blasted (40 microns) before applying Belzona 1321 to the draft tube and Belzona 1341 to stay ring and vanes. Finally Belzona 2941 & Belzona 2141 were applied to the tips of the stay vanes for their anti-cavitation properties.
