Solving the Sealing Problem on the Roof of the Fuel Storage Tank with Belzona

ID: 8708

Customer Location: Tank Farm, TURKEY
Application Date: April 2021

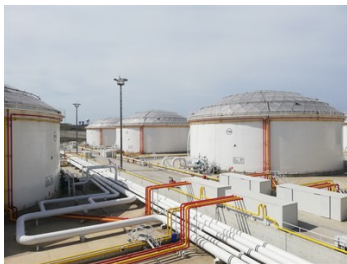
- * 1.) General view of fuel storage tanks ,
- * 2.) Failed current system ,
- * 3.) Taping and Belzona 3921 application ,
- * 4.) A view from the Belzona 3111 application ,

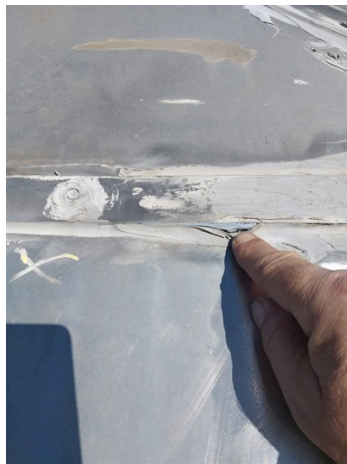
Rainwater was leaking from the external surface of the tank roof through the seams. The client tried to use a different system to fix the problem, although that solution was unsuccessful.

This application was carried out in accordance with a modified version of system leaflet TCC-04. After decontamination of the previously applied and unsuccessful systems, surface preparation and then cleaning with the Belzona 9111 was carried out on the application substrate. Belzona 3921 conditioner was then applied to the substrate to ensure the Belzona 3111 would adhere. In order to ensure tightness, Belzona 3111 was applied in two layers, incorporating Belzona 9311 reinforcement tape.
