BELZONA PROTECTS HOT WATER TANKS

ID: 871

Customer Location: State Correctional Facility, Missouri
Application Date: February 2007

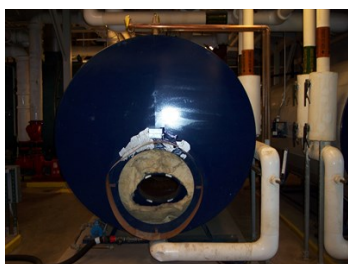
- * The tank inside the Powerhouse ,
- * View of the internal corrosion ,
- * Contractor applying 2nd coat of Belzona® 5811 ,
- * Technical Consultant inside the finished tank 2 days later ,

Hot water generation tanks within the Powerhouse.

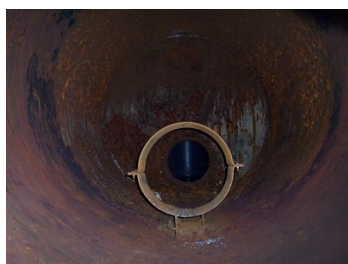
Severe internal corrosion

Application was carried out in accordance with Belzona Know-How System Leaflet TCC-5.
