# Internal Joint Repair to Stainless Steel Pasteuriser at a Brewery

ID: 8753

Customer Location: Derbyshire, UK  
Application Date: March 2022

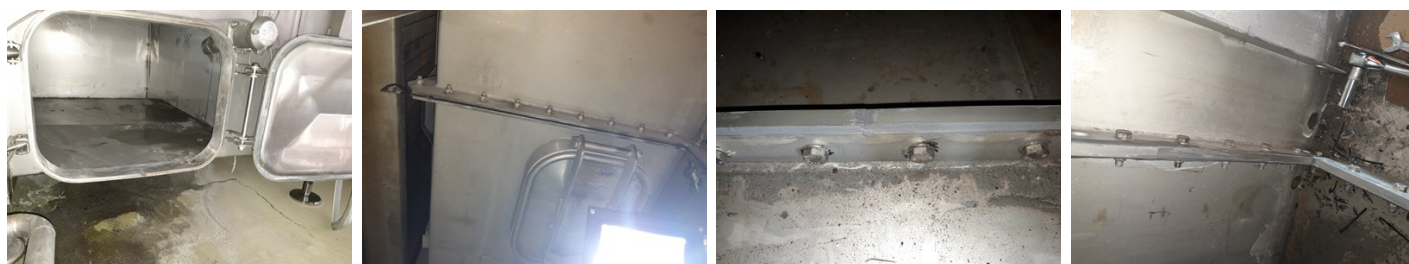
*A stainless steel pasteurising bottling line had a large leak from a joint. The pasteurizer could not be disassembled to replace the gasket and therefore the only option was to seal the joint in situ.*

\* 1. Leaking pasteuriser 2. Surface of the seam prepared prior to repair 3. Belzona 1511 used to bond plates in place 4. Completed repair ,

The internal seal between two sections of the stainless steel pasteurising bottling line had developed a leak.

All of the exposed mastic material between the joint was removed. The repair area was then mechanically prepared using a hand-held industrial surface preparation tool. Belzona 1511 was then applied to both the joint and pre-formed plates using a stiff brush to eliminate air entrapment. The plates were then bonded onto the substrate.
