# Belzona Repairs Chemical Storage Room Floor

Industry: General Industry  
Application: FPA-Floor Problem Areas  
Substrate: Concrete  
Products: \* Belzona 4131 (Magma-Screed) ,  
\* ,

Customer Location: Doncaster, UK  
Application Date: March 2022

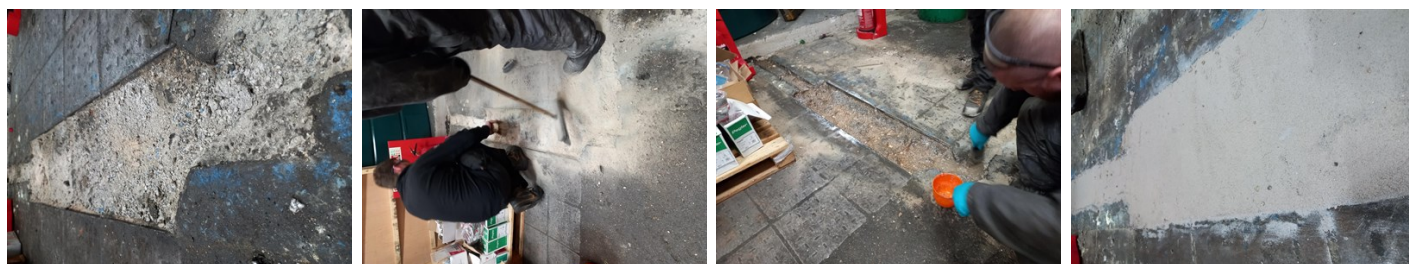
## Photograph Descriptions

Steel tiles had failed in one area of a chemical storage area, leaving damaged concrete. Any repairs needed to be able to protect against water and general chemical use.

- \* 1. Target area identified for training purposes ,
- \* 2. Cleaning out the loose and friable materials ,
- \* 3. Belzona 4911 Conditioner mixed and applied ,
- \* 4. Belzona 4131 laid, compressed and smoothed to finish ,

All loose and friable materials were removed from the target area, using a wire brush, soft brush and compressed air. The area was conditioned using Belzona 4911 (TX-Conditioner). Following the conditioning, Belzona 4131 was applied, and were finished level with the rest of the floor.
