Belzona Repairs Francis Turbine In Hydro-Power Plant

ID: 8760

Customer Location: Portugal
Application Date: 2021

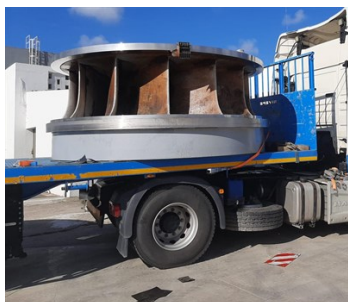
After years in service the Francis turbine has begun to corrode and erode.

- * 1.) Francis turbine prior to application, visibly damaged ,
- * 2.) Francis turbine after grit blasting ,
- * 3.) 1st coat of Belzona 1341 applied ,
- * 4.) Final application ,
