# Belzona Repairs Francis Turbine In Hydro-Power Plant

ID: 8760

Customer Location: Portugal  
Application Date: 2021

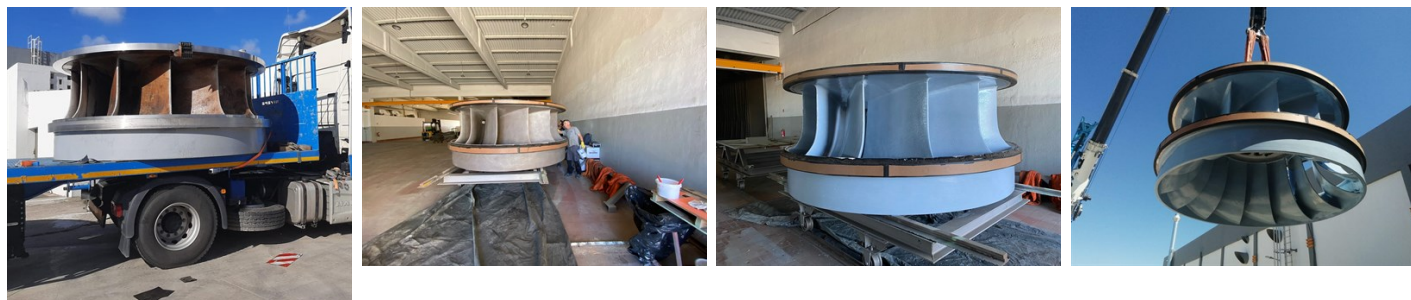
After years in service the Francis turbine has begun to corrode and erode.

- \* 1.) Francis turbine prior to application, visibly damaged ,
- \* 2.) Francis turbine after grit blasting ,
- \* 3.) 1st coat of Belzona 1341 applied ,
- \* 4.) Final application ,

This application was carried out in accordance with system leaflet CEP-03 and CEP-10. The Francis turbine arrived in the workshop with visible signs of corrosion, erosion and rust. The Francis turbine was cleaned and grit blasted to SA2.5, achieving a surface profile of 75 microns. After the cleaning & blasting process, 2 coats of Belzona 1341 were applied to the whole turbine.
