# Sump repair & coating works

ID: 8762

Industry: Food & Drink  
Application: TCC-Tanks and Chemical Containment Areas  
Substrate: Concrete & Brick  
Products: \* Belzona 4131 (Magma Screed) ,  
\* Belzona 4911 (TX Conditioner) ,  
\* Belzona 5811 (Immersion Grade) ,

Customer Location: Scotland  
Application Date: February 2022

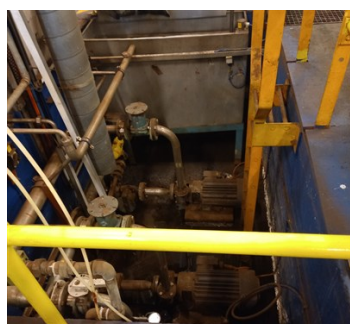
The sump had deteriorated through spillages & nearby leaks. Limited downtime was available for these works as they were to be carried out during a shutdown.

- \* 1) Sump before ,
- \* 2) Surface preparation complete & Belzona 4131 installed ,
- \* 3) Belzona 4131 applied to the floor & Belzona 5811 first coat applied to the walls ,
- \* 4) 2nd coat of Belzona 5811 applied ,
