# Belzona Protects Switch Gear Boxes at a Wind Farm

Customer Location: Wind Farm, TX  
Application Date: 2021

Switch boxes at the base of turbine columns.

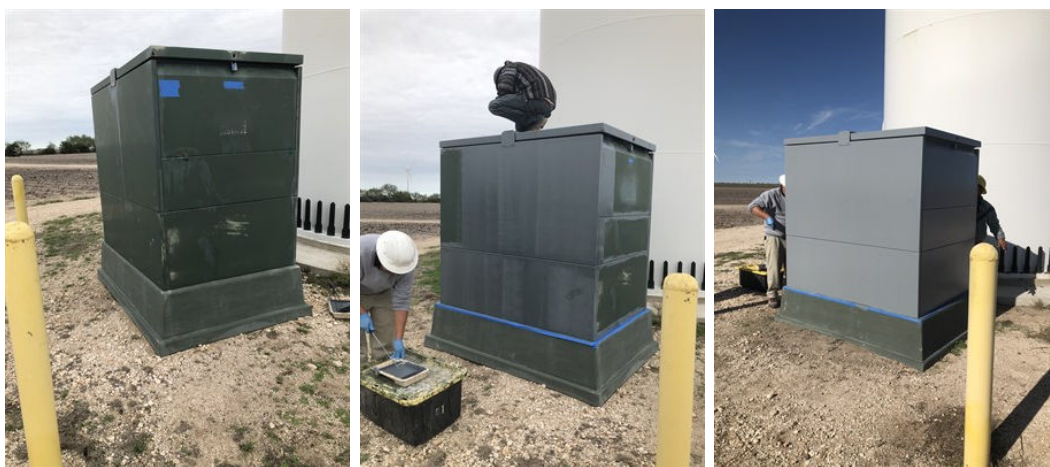
*Damage on the metallic surface caused by corrosion from the salt environment. If neglected, wall thickness deteriorates and the asset integrity becomes compromised.*

- \* The surface is cleaned and manually prepared. ,
- \* Belzona 3921 Conditioner is applied. ,
- \* Belzona 5111 is applied and the applications is complete. ,

The location of the switch gear boxes made it easy to prep and apply coatings. Abrasive blasting was not allowed. Orbital sanders were used to acquire a surface provided required to apply coatings. First, the Switch Gear Boxes were coated with Belzona 3921 Conditioner that is zinc rich and also acts as a corrosion inhibitor. Then, Belzona 5111 was then applied for the finish UV protection and final environmental protection. The application was carried out in accordance with the Belzona System Leaflet CEP-4 and Instructions for Use.
