Belzona Repairs and Protects Wind Turbine Columns

ID: 8771

Customer Location: Wind Farm, TX
Application Date: 2022

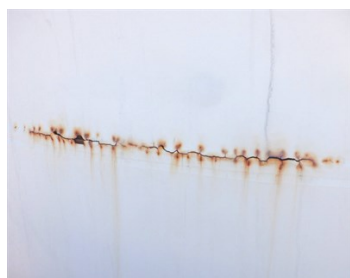
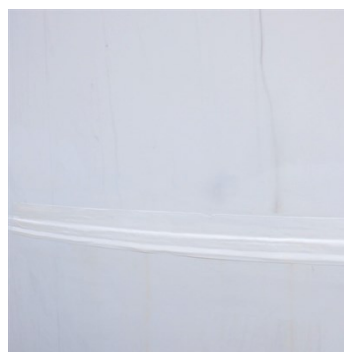
Photograph Descriptions

Damage on the surface of the columns caused by salt deposits from rain and fog settlements. Elements create corrosive areas on equipment and metallic columns are no exception. The Customer felt if the issue was not addressed in due time, through-wall defects could lead to a loss of structural integrity, which could pose a bigger issue long-term.

- * Showing damage. ,
- * The area is prepped using an MBX Bristle Blaster, and masked off for the application. ,
- * Belzona 1331 is applied and the application is complete. ,

Customer needed a solution requiring minimal effort from labor. Access was only by wire rope and staging basket. Abrasive media blasting was not allowed. An MBX Bristle Blaster was used to acquire a surface profile of 3 mils. MEK was used to clean and degrease the application area. Then one high-build coat of Belzona 1331 was applied by brush in one staging. The application was carried out in accordance with a modified version of Belzona System Leaflet CEP-4 and Belzona 1331 Instructions for Use.
