# Belzona 4301 Rebuilds An Acid Intake Nozzle

ID: 8772

Industry: Chemical & Petrochemical  
Application: VPF-Valves, Pipes and Fittings  
Substrate: Steel  
Products: \* Belzona 4301 (Magma CR1 Hi-Build) ,

Customer Location: South Africa  
Application Date: February 2022

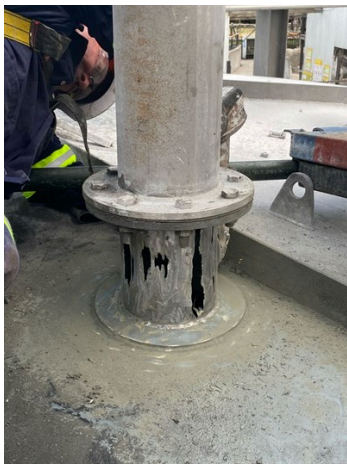
*The acid used in the process had severely damaged steel, affecting its structural integrity*

- \* 1 - Initial condition ,
- \* 2- Surface Preparation ,
- \* 3 - Belzona 4301 Application ,
- \* 4 - Belzona 4301 Application ,

An acid intake nozzle was severely compromised, requiring an urgent repair.
