# Belzona Protects Against Corrosion In Fan Shroud

ID: 8775

Industry: *Pulp & Paper*  
Application: *FBC-Fans, Blowers and Compressors*

Customer Location: *Jacksonville, Florida*  
Application Date: *2022*

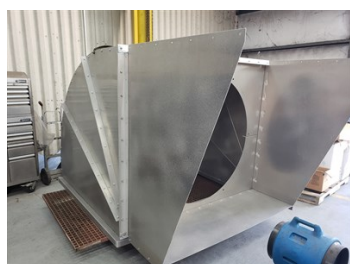
*A brand new paper milling fan shroud picks up a lot of caustic mist, eventually corroding the inside of the shroud. A coating was then required to protect the shroud from the corrosion that would have eventually formed over time.*

Fan shroud.

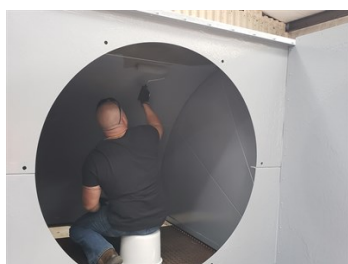
Fan shroud being coated.

Preparation was done by a combination of abrasive blasting and MBX by hand to achieve a SP10 near white metal finish for a good mechanical adhesion. Belzona 5811 was then mixed and applied as two coats on the shroud.

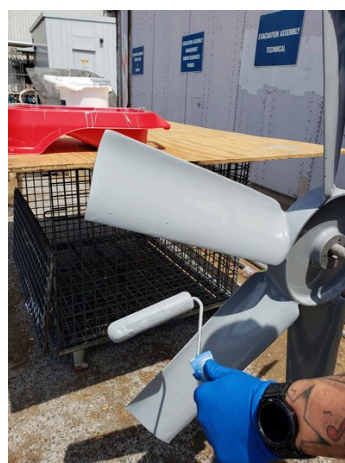
Fan being coated

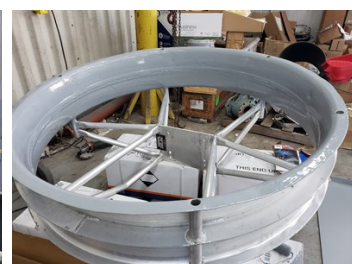
Coated pieces.
