TANK BASE SEALING WITH BELZONA SOLUTION

ID: 878

Industry: Power
Application: GSS-Gaskets, Seals and Shims
Substrate: Carbon Steel/ Concrete
Products: Belzona® 3111 (Flexible Membrane)

Customer Location: Coal Fired Power Plant, Missouri
Application Date: 2007

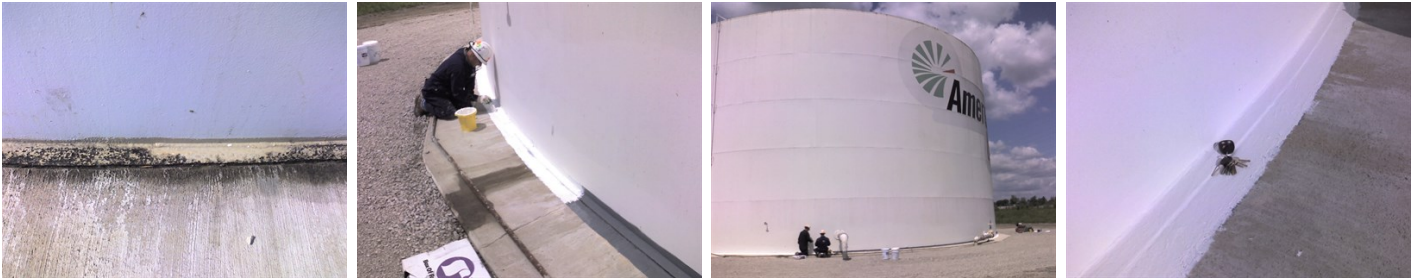
Photograph Descriptions

Moisture was seeping through the concrete tank pad and collecting under the tank. Plant officials feared that the tank bottom would be compromised by subsequent corrosion.

* Chime angle before application , * Application underway , * View of tank size , * Completed Application ,

Application was carried out in accordance with a modified version of Belzona Know-How System Leaflet GSS-3

Other products had failed to seal the chime angle. Plant engineers were needing a reliable product that would adhere to both substrates. Belzona was chosen for its ease of application and excellent reputation. The application was completed quickly and effectively.
