Belzona Rebuilds Grundfos Pump Impeller for the Wastewater Industry

ID: 8785

Industry: Water / Wastewater

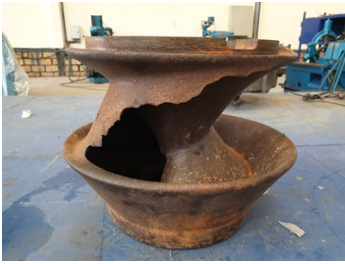
A Grundfos pump impeller had been severely damaged during normal service by erosion and corrosion.

* 1). Damaged pump impeller. 2). Pump impeller with leading edge armament. 3). Leading edge rebuilt using Belzona 1311. 4). Completed application with final coat of BZ1321. ,
