# Belzona Rebuilds Grundfos Pump Impeller for the Wastewater Industry

ID: 8785

Industry: Water / Wastewater

Customer Location: Casablanca, Morocco

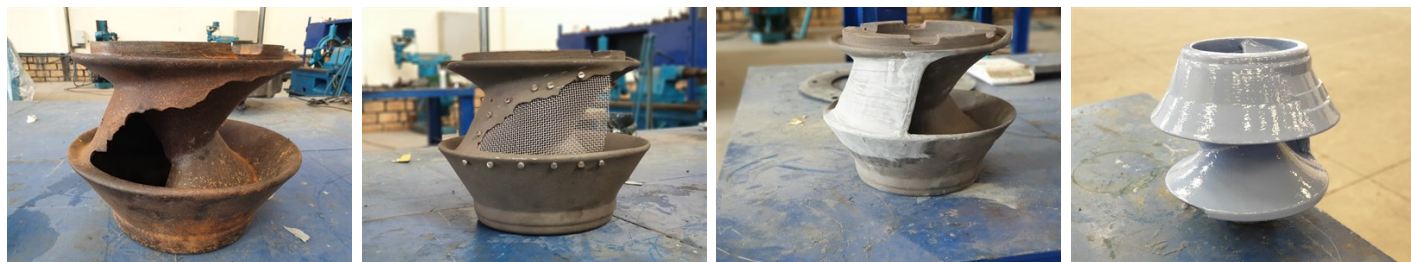
A Grundfos pump impeller had been severely damaged during normal service by erosion and corrosion.

\* 1). Damaged pump impeller. 2). Pump impeller with leading edge armament. 3). Leading edge rebuilt using Belzona 1311. 4). Completed application with final coat of BZ1321. ,

A thin sheet of metallic armament was attached to provide support and shape to the leading edge of the impeller. It was then rebuilt using Belzona 1311 and overcoated with Belzona 1812 to provide further abrasion resistance. Belzona 1321 was then applied over the whole impeller to provide not only erosion resistance but also a physical corrosion barrier. The application was carried out in accordance with Belzona System Leaflet CEP-01.
