Belzona Brings New Life to an Alstom Sea Pump Turbine

ID: 8788

Alstom sea pump turbine at a Thermal Power Plant.

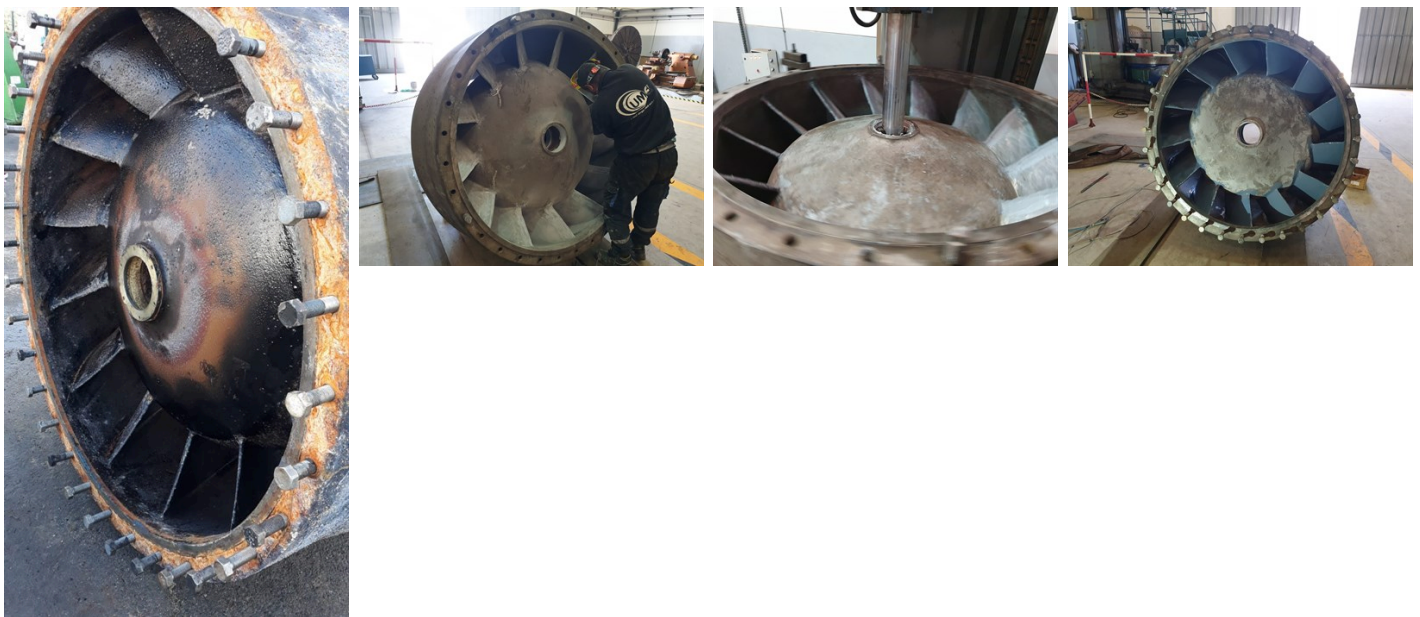
Photograph Descriptions

The leading edges of the vanes were severely damaged due to erosion and corrosion, along with the bearing housing of the turbine.

- * 1). Original damaged state of the turbine. ,
- * 2). Rebuilding of the leading edge on the vanes. ,
- * 3). Rebalancing of the Turbine. ,
- * 4). Completed application of the Turbine. ,

The leading edges of the vanes were rebuilt using Belzona 1311 and the turbine was then rebalanced to ensure optimum operating efficiency without causing residual wear to any auxiliary equipment. These were then coated using Belzona 1321 to provide erosion-corrosion protection. The bearing was also repaired to its original profile to ensure a perfect fit with the turbine shaft. The

application was carried out in accordance with Belzona System Leaflet PDP-03 & PDP-05.
