# Seawater Pump gets the full Belzona Service

ID: 8789

**Customer Location:** Jorf Lasfar, Morocco  
**Application Date:** March 2019

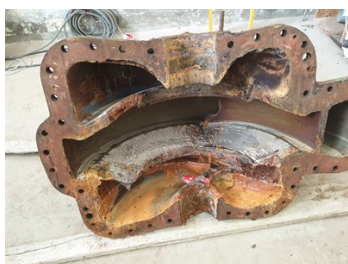
The Kirloskar seawater pump was suffering from general corrosion and bi-metallic corrosion (galvanic corrosion) on the wear rings.

- \* 1). Original condition of the seawater pump casing. ,
- \* 2). Wear rings and cutwaters being rebuilt using Belzona 1111. ,
- \* 3). Pump impeller rebuilt and protected. ,
- \* 4). Completed seawater pump application. ,
