# EXPANSION JOINT AT HOSPITAL SEALED WITH BELZONA

Industry: *Buildings & Structures*  
Application: *FPA-Floor Problem Areas*  
Substrate: *Concrete*  
Products: *Belzona® 4111 (Magma Quartz)* <br /> *Belzona® 2221 (MP Fluid Elastomer)*

Customer Location: *Hospital, Missouri*  
Application Date: *2007*

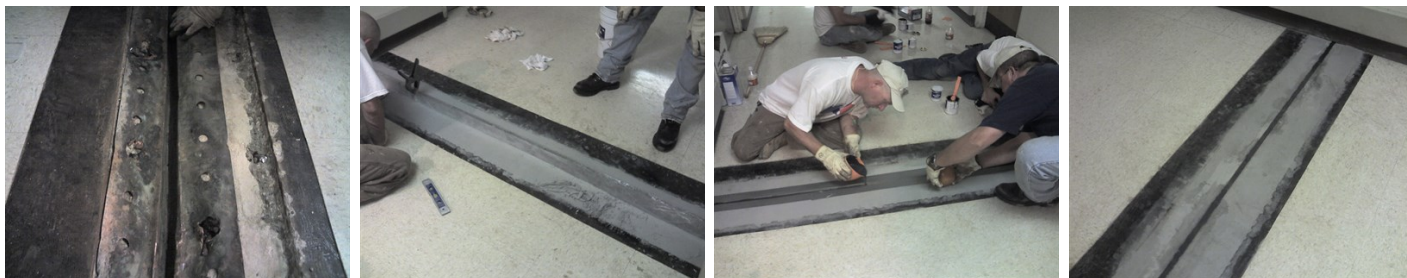
*Expansion joints in the hospital had become a tripping hazard*

\* View of joint with kick plate removed , \* Application of Belzona® 4111 , \* Application of Belzona® 2221 , \* Completed application ,

Expansion joints in corridor in need of repair

Application was carried out in accordance with Belzona Know-How System Leaflets FPA-5 and -6.

The hospital needed a fast-curing and reliable method for repairing expansion joints that were creating trip hazards for patients.
